Inspection Report
Minerals Regulatory Program
August 18, 2005

Mine Name: Mammoth Ridge 1
Operator Name: Burningham Enterprises

Permit number: S/017/048
Inspection Date: August 2, 2005
Time: 1:00 PM – 2:15 PM

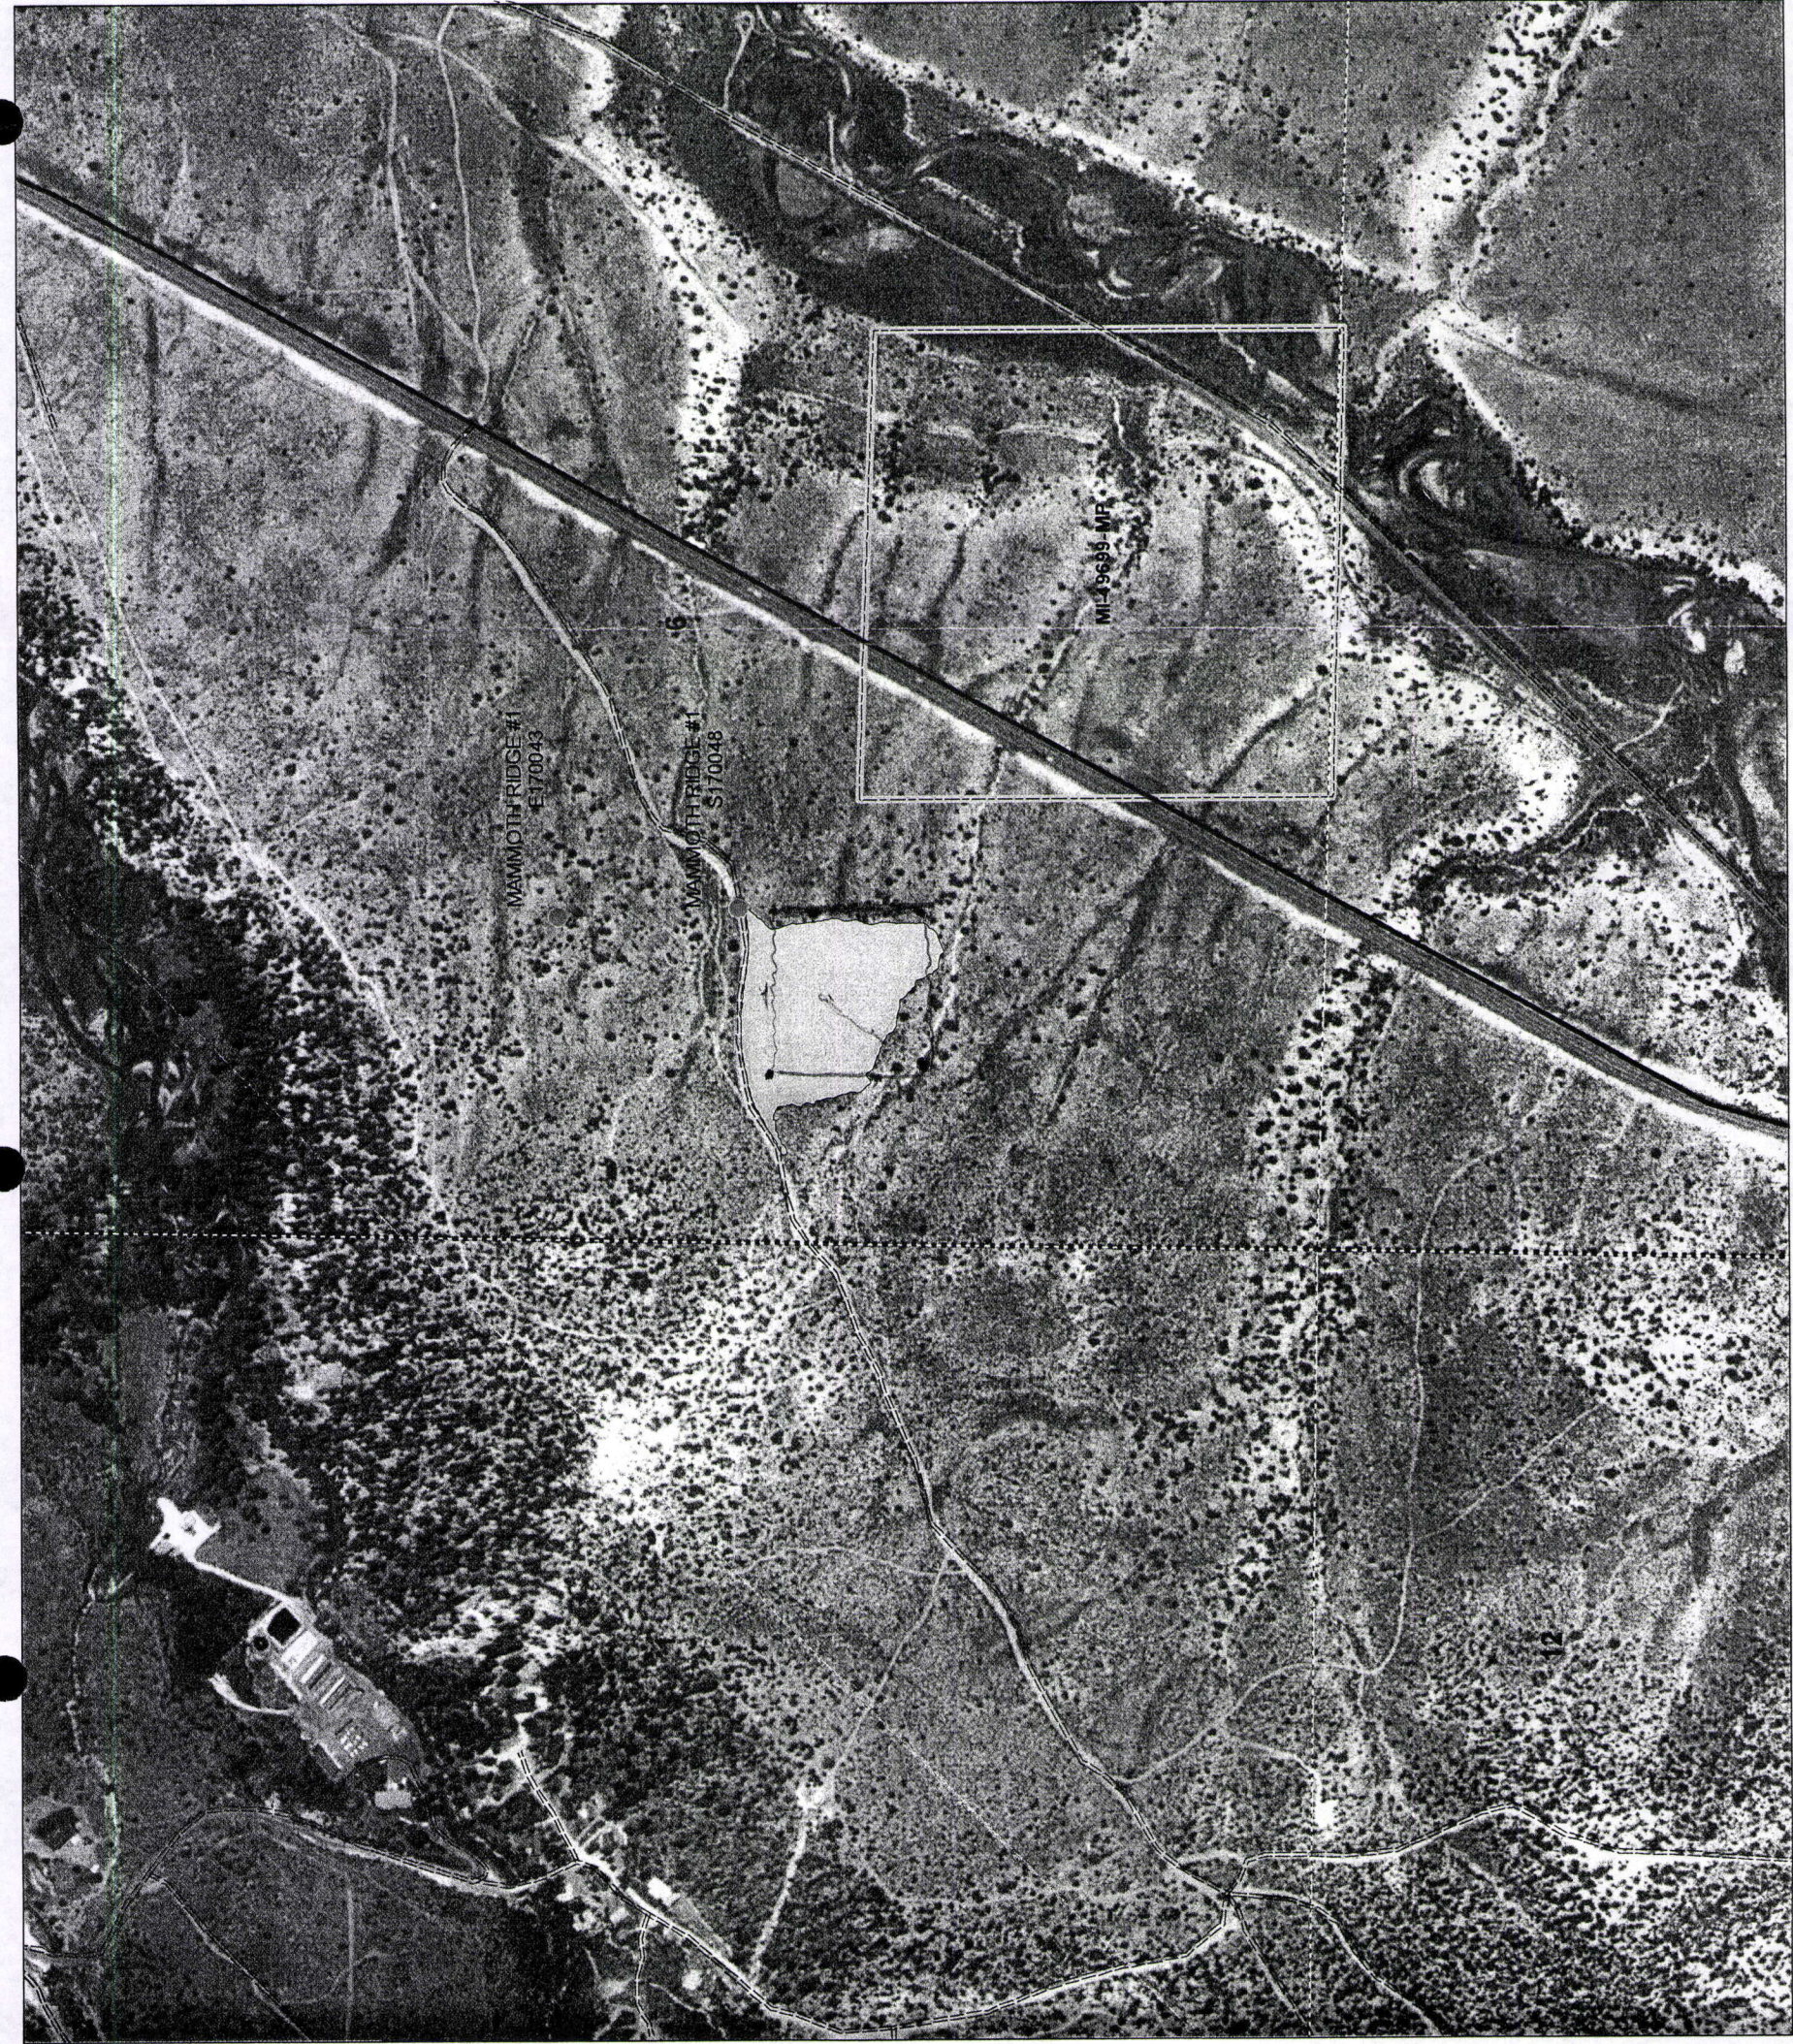
Mine Number: S170048
Mine Name: Mammoth Ridge 1
Township 37 S Range 05 W

The GPS map of the site showed that the disturbance at the site totaled 5.23 acres. Burningham Enterprise's permit application stated that 4.5 acres would be disturbed and the reclamation bond was calculated on that basis. **Because the operator has disturbed more than 5 acres, he should immediately begin efforts to submit a large mine application to the Division.**

Acres Disturbed	5.23
Acres Regraded	0
Acres Seeded	0
Total Acres Disturbed	5.23
Acres Reclaimed	0
Acres Excluded	0
Acres Prelaw	0

Mr. Burningham should begin efforts immediately to prepare and submit a NOI-LMO (large mine) application to the Division.
